# **INDOOR AIR QUALITY ASSESSMENT**

**Department of Public Works  
Highway Building Garage  
33 Lindbergh Ave  
Methuen, Massachusetts**

Prepared by:  
Massachusetts Department of Public Health  
Bureau of Environmental Health  
Indoor Air Quality Program  
September 2017

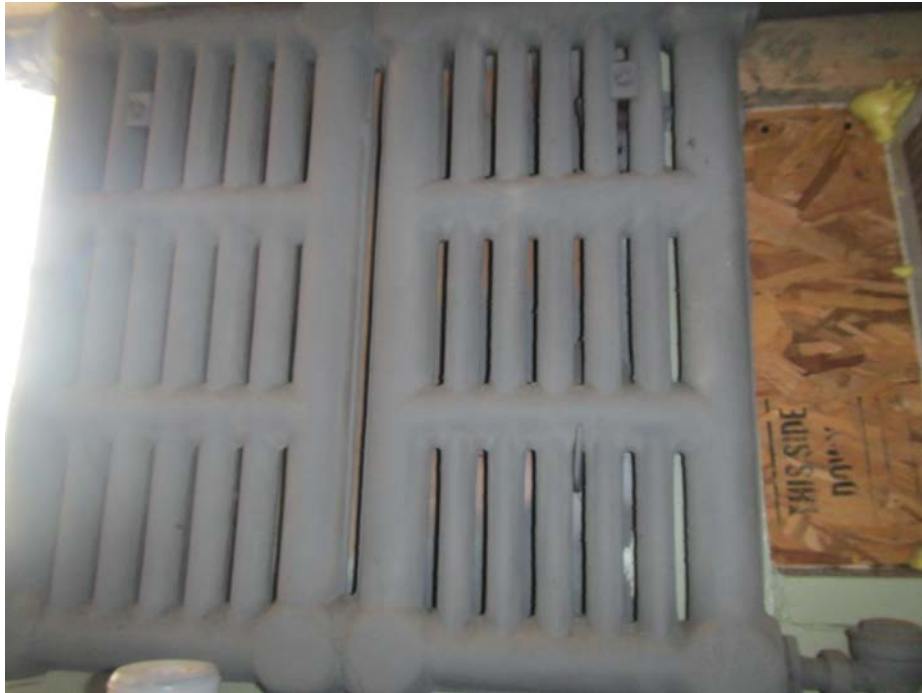
**Picture 1**

It can be seen from Table 1 that carbon dioxide levels were below 800 ppm in all areas surveyed. The office area does not appear to have mechanical ventilation to introduce fresh air into the space; heat is provided by an oil-fired boiler connected to steam radiators (Picture 1). Fresh air in the office area is supplied primarily by open windows and infiltration through gaps in the building envelope. Window-mounted air conditioning (AC) units, which supply some fresh air to the space, were operating at the time of the assessment. Setting the AC units to “fan only” would provide fresh, filtered air during temperate weather, but is impractical during the winter months.

**Radiator in office area**

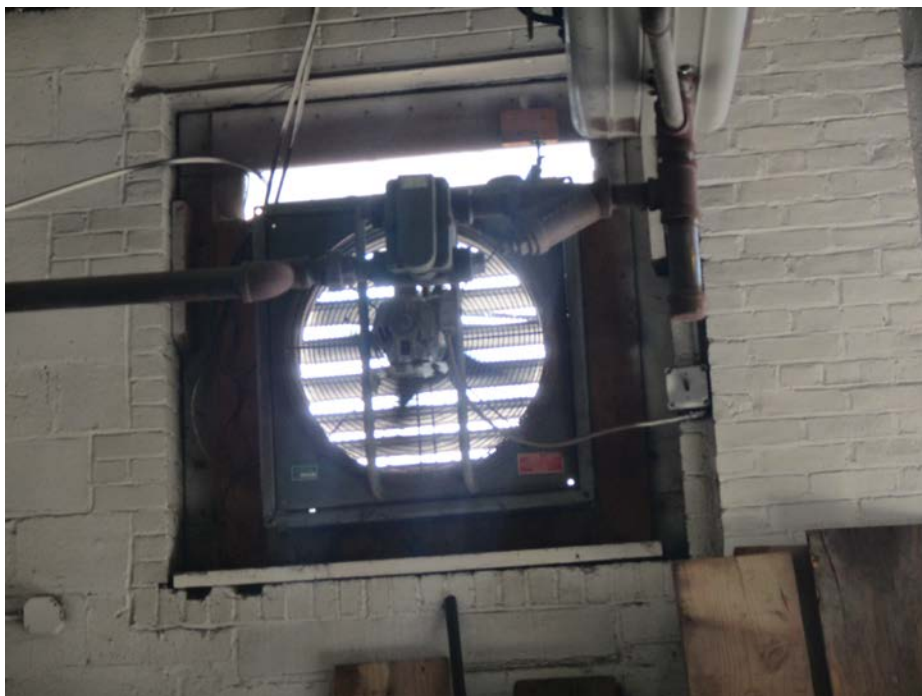
**Picture 2**

The main garage area has several general exhaust fans (Picture 2) that are operated on an as-needed basis. There is a large, fabric “sock-type” make-up air supply duct (Picture 3) to introduce fresh air during the operation of the exhaust fans. Ideally, make-up air supply louvre vents would be sited on the wall opposite the exhaust fans to allow the fan to clear and eject products of combustion from the garage, while the supply vent replaces the ejected air with fresh air. It was reported that DPW staff typically leave the garage doors open to further increase air circulation.

**Exhaust fan in main garage**

2. Utilize existing general exhaust ventilation and spot ventilation whenever combustion activities are performed (e.g., vehicle emissions, welding, etc.).

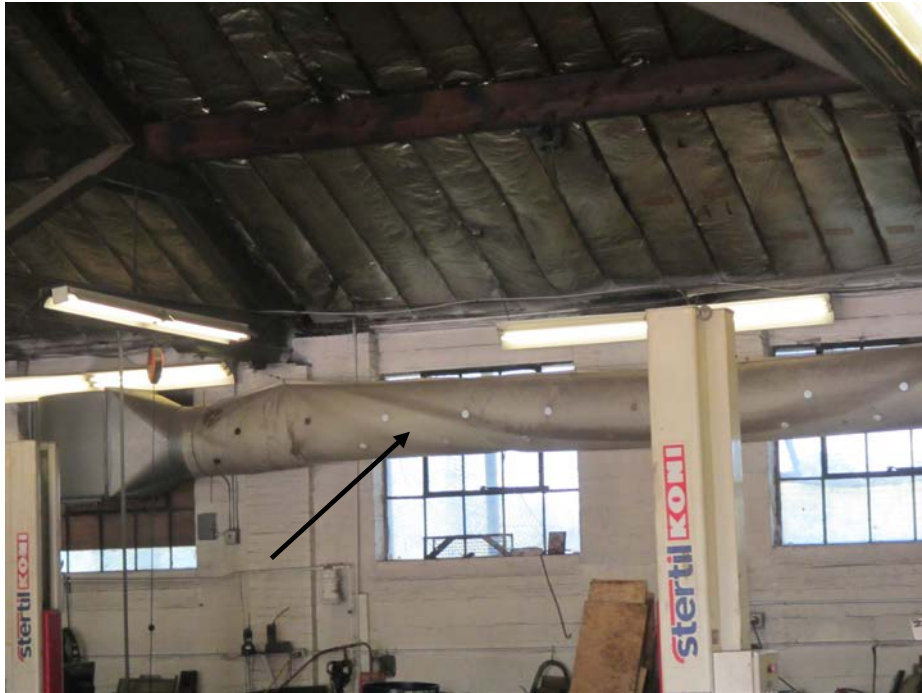
**Picture 3**

**Fabric “sock-type” make-up air supply duct**

3. Ensure adequate make-up air supply during the use of ventilation systems to effectively clear and eject products of combustion from the garage bays.

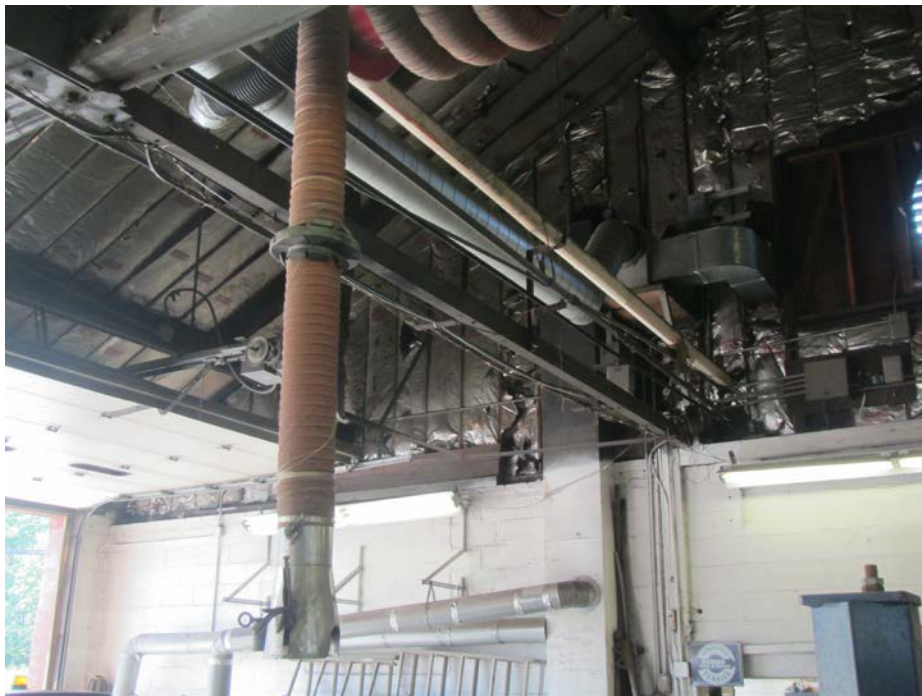
**Picture 4**

Of particular importance is vehicle exhaust, which is a product of combustion. Local mechanical exhaust ventilation systems are installed in some areas of the garage to remove airborne pollutants (e.g., odors, fumes, carbon monoxide, and other products of combustion) during vehicle idling (Picture 4). The system is designed to collect vehicle exhaust directly at the source and remove it from the building, minimizing exposure. Vehicle idling indoors should be performed only when absolutely necessary/if needed and the tailpipe mechanical exhaust system should be used during vehicle idling.

**Vehicle tailpipe exhaust system**

1. Refrain from idling vehicles indoors unless absolutely necessary. Any idling should be performed utilizing the tailpipe mechanical exhaust systems in the garage.

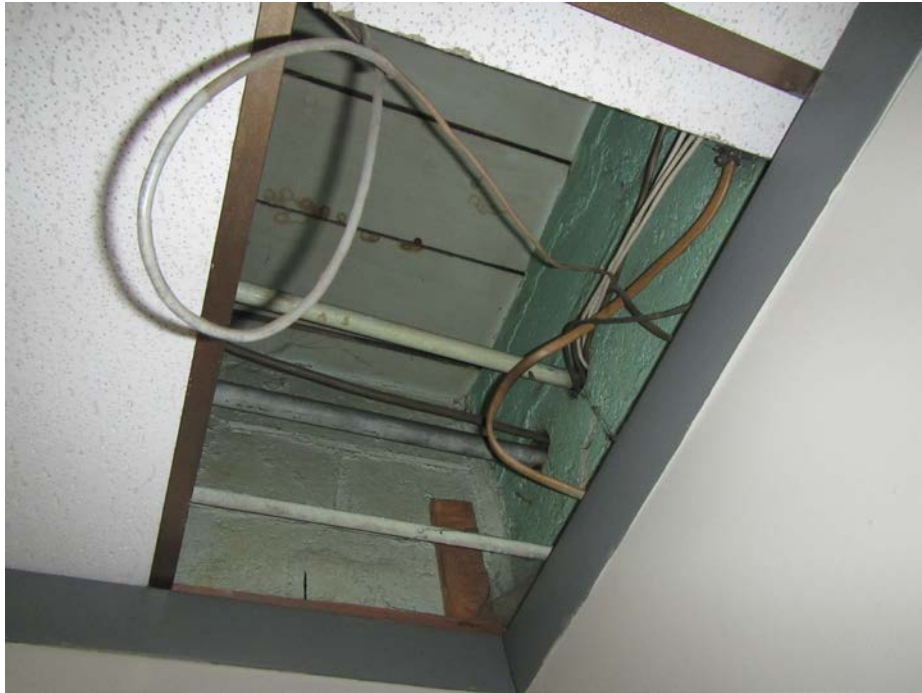
**Picture 5**

IAQ staff noted several missing or ajar ceiling tiles in the DPW office area (Picture 5). These missing tiles may also serve as a pathway for moisture, odors, and pollutants to enter the office from the garage area.

**Missing ceiling tiles in office area**

5. Replace missing ceiling tiles and seal any other gaps or breaches in the shared walls and ceilings between occupant areas and garage bays to avoid the intrusion of particulate matter, odors, and water vapor into occupied areas.

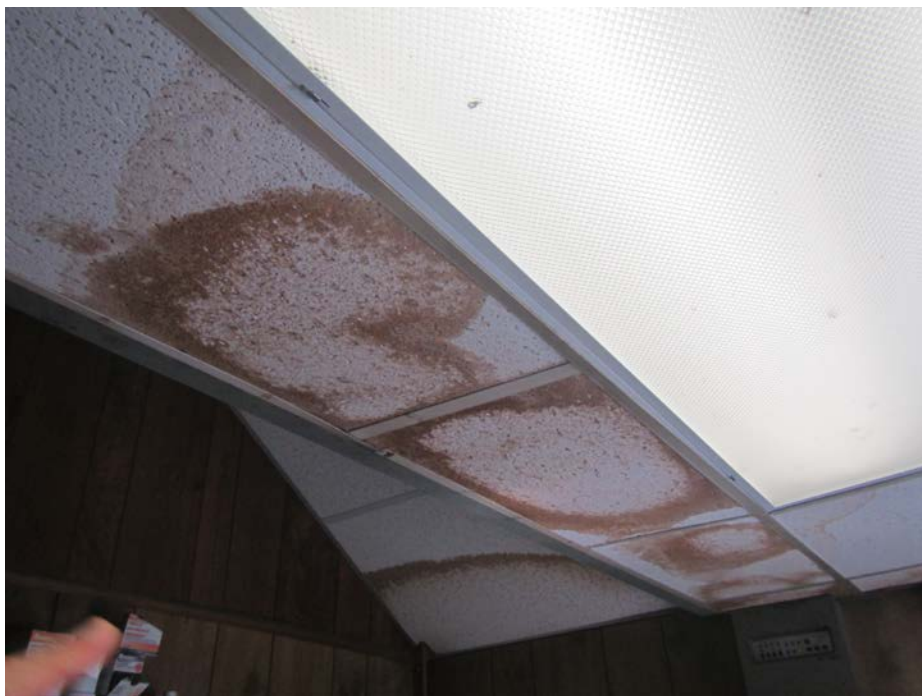
**Picture 6**

- DPW garages are normally exposed to moisture from vehicles and activities;
- Most building materials at the DPWG are made from materials that are *not* conducive to mold growth (e.g., concrete walls and flooring);
- Porous items (e.g., ceiling tiles, gypsum wallboard) that become wet and are not dried within 24-48 hours should be discarded and replaced (Picture 6);

**Water-damaged ceiling tiles in office area**

6. Continue with plans to ramp up rodent/pest control efforts at this facility. Consider adopting an IPM plan for more effective pest elimination.
7. Discard water-damaged ceiling tiles found in the office areas and replace with new tiles.

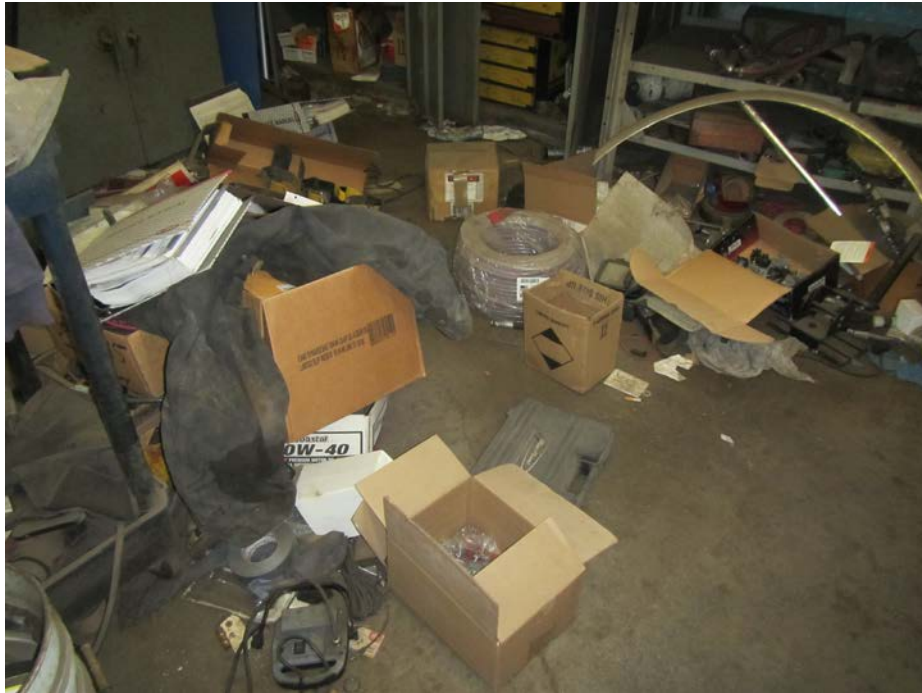
**Picture 7**

- Cardboard boxes and other porous materials were observed directly on the floor of the DPWG (Picture 7). Cardboard boxes and other porous materials should be elevated to prevent wetting from garage activities or condensation, which can lead to water damage and mold growth;
- DPW staff reported that the main garage had a new roof installed approximately five years ago;
- The AC unit in the second floor main office of the old garage appeared to be missing a filter and was occluded with dust (Picture 8). This filter should be replaced to avoid the accumulation of dust and debris in the unit which, together with condensation, has the potential to support microbial growth. AC filters/units should also be cleaned regularly to avoid aerosolizing particulate matter which could serve as a respiratory irritant.

**Various cardboard boxes stored directly on concrete floor**

8. Do not store porous materials (e.g., cardboard boxes, paper items) directly on floors; elevate/place on pallets or shelving to prevent water damage and mold growth. Discard any existing water-damaged porous materials.

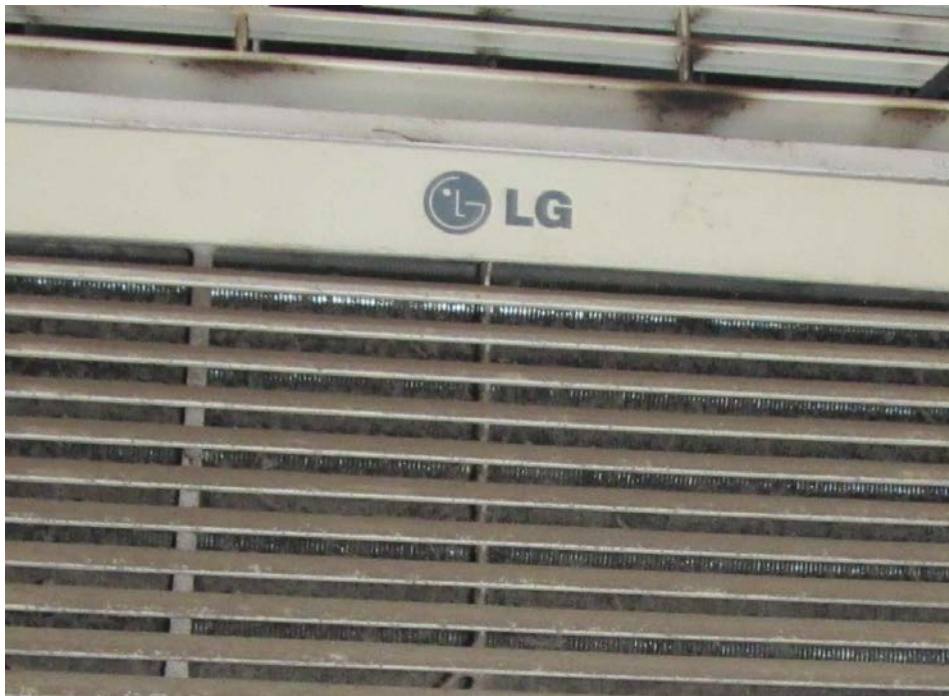
**Picture 8**

**Office AC unit showing dust/debris and missing filter**

9. Ensure regular cleaning of Window AC units and filters. Replace filter in AC unit found in office area. These AC units may be set to “fan only” to provide a limited amount of fresh air to office areas.

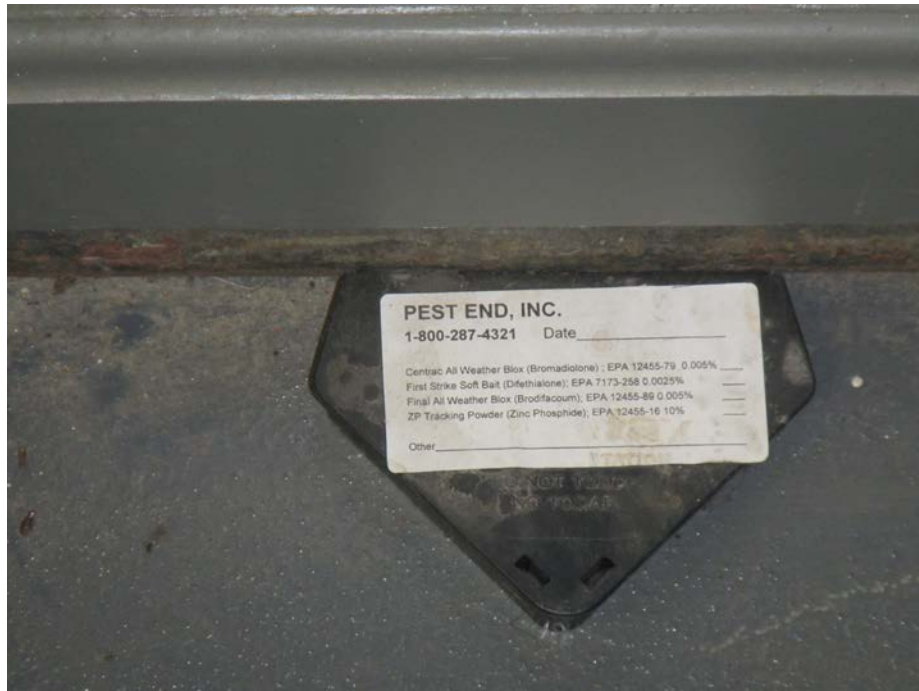
**Picture 9**

The original DLS referral indicated rodent concerns in the building. Most employees did not report seeing rodents except for those working night shifts. IAQ staff noted the presence of bait stations in the office and garage areas (Picture 9). DPW staff reported that a pest control company provides service approximately every two weeks. DPW staff also reported that plans to increase rodent control are underway. In any pest elimination strategy, it is important to not only bait or trap rodents that get into the building but also seal any pathways, remove areas of harborage, and eliminate food sources. It may be necessary to also close garage doors especially before sunset to prevent easy access for rodent entry into the building. The MDPH recommends the implementation of an Integrated Pest Management (IPM) plan in addition to traditional pest baiting/trapping methods to more effectively control pest issues. The IPM guideline can be found at: <http://www.mass.gov/eea/docs/agr/pesticides/publications/ipm-kit-for-bldg-mgrs.pdf>.

**Rodent bait box in office area**

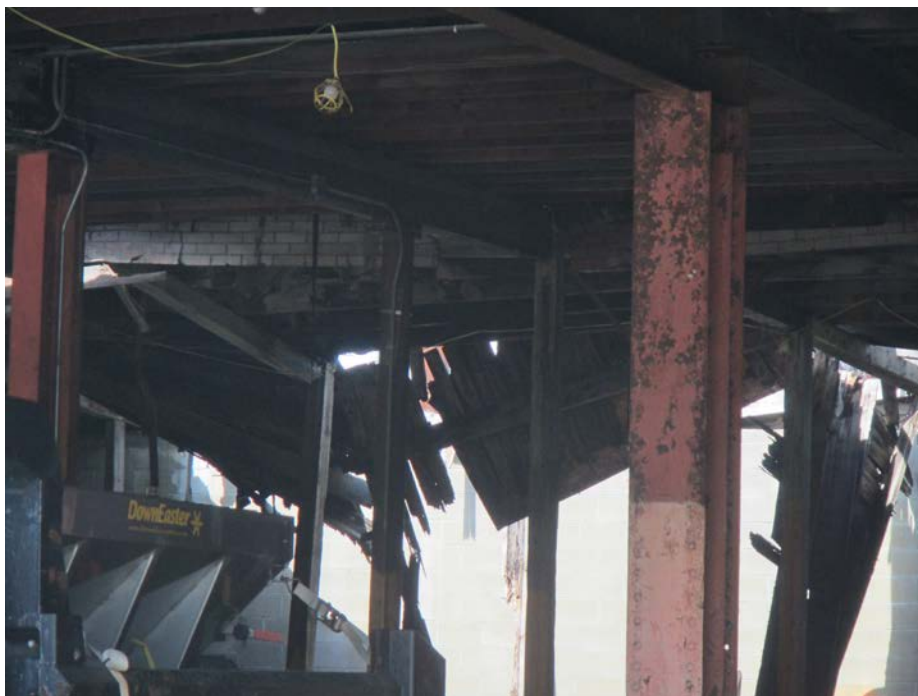
**Picture 10**

Several sections of the DPW garage building are not useable due to structural issues that make these areas unsafe (Picture 10). In addition to safety/moisture concerns, these areas may allow additional harborage for pests. It was reported by DPW staff that they are in the beginning process of designing a new facility to remedy these concerns.

**Multiple bays attached to DPWG deemed structurally unsafe**

11. Continue with plans to design and replace the DPW garage, especially the areas that were deemed to be structurally unsafe and that may be contributing to moisture/pest issues.
